October, 2021 Oriental Motor USA, Corp.

[Important Notice] Notice and Request Concerning the Safety of Our Motor Driver

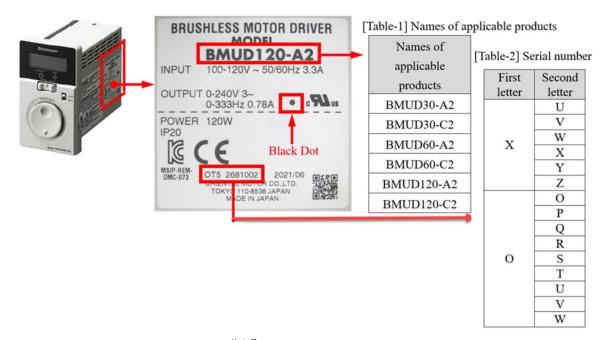
Please check the information on <u>the nameplate located on the side of the product</u>. Applicable product meets all three of the following conditions.

- 1) The product name is listed in [Table-1].
- 2) " \bullet " (a black dot) is found.
- 3) Combination of the first and second letters of the serial number is listed in [Table-2].

Note: If the driver label has a black dot "●" (a black dot) as noted below, the drier has a fully secured dial and is not impacted by this issue.
